PHASE I INSPECTION REPORT

NATIONAL DAM SAFETY PROGRAM

Graham's Dam (VA-00342). James River Basin.
Albemarle County, State of Virginia.

Name of Dam: Grahams Dam
State: Virginia
County: Albemarle
USGS 7.5 Minute Quadrangle: Charlottesville East, VA
Stream: Unnamed Tributary to Camp Branch
Date of Inspection: 12 November 1979

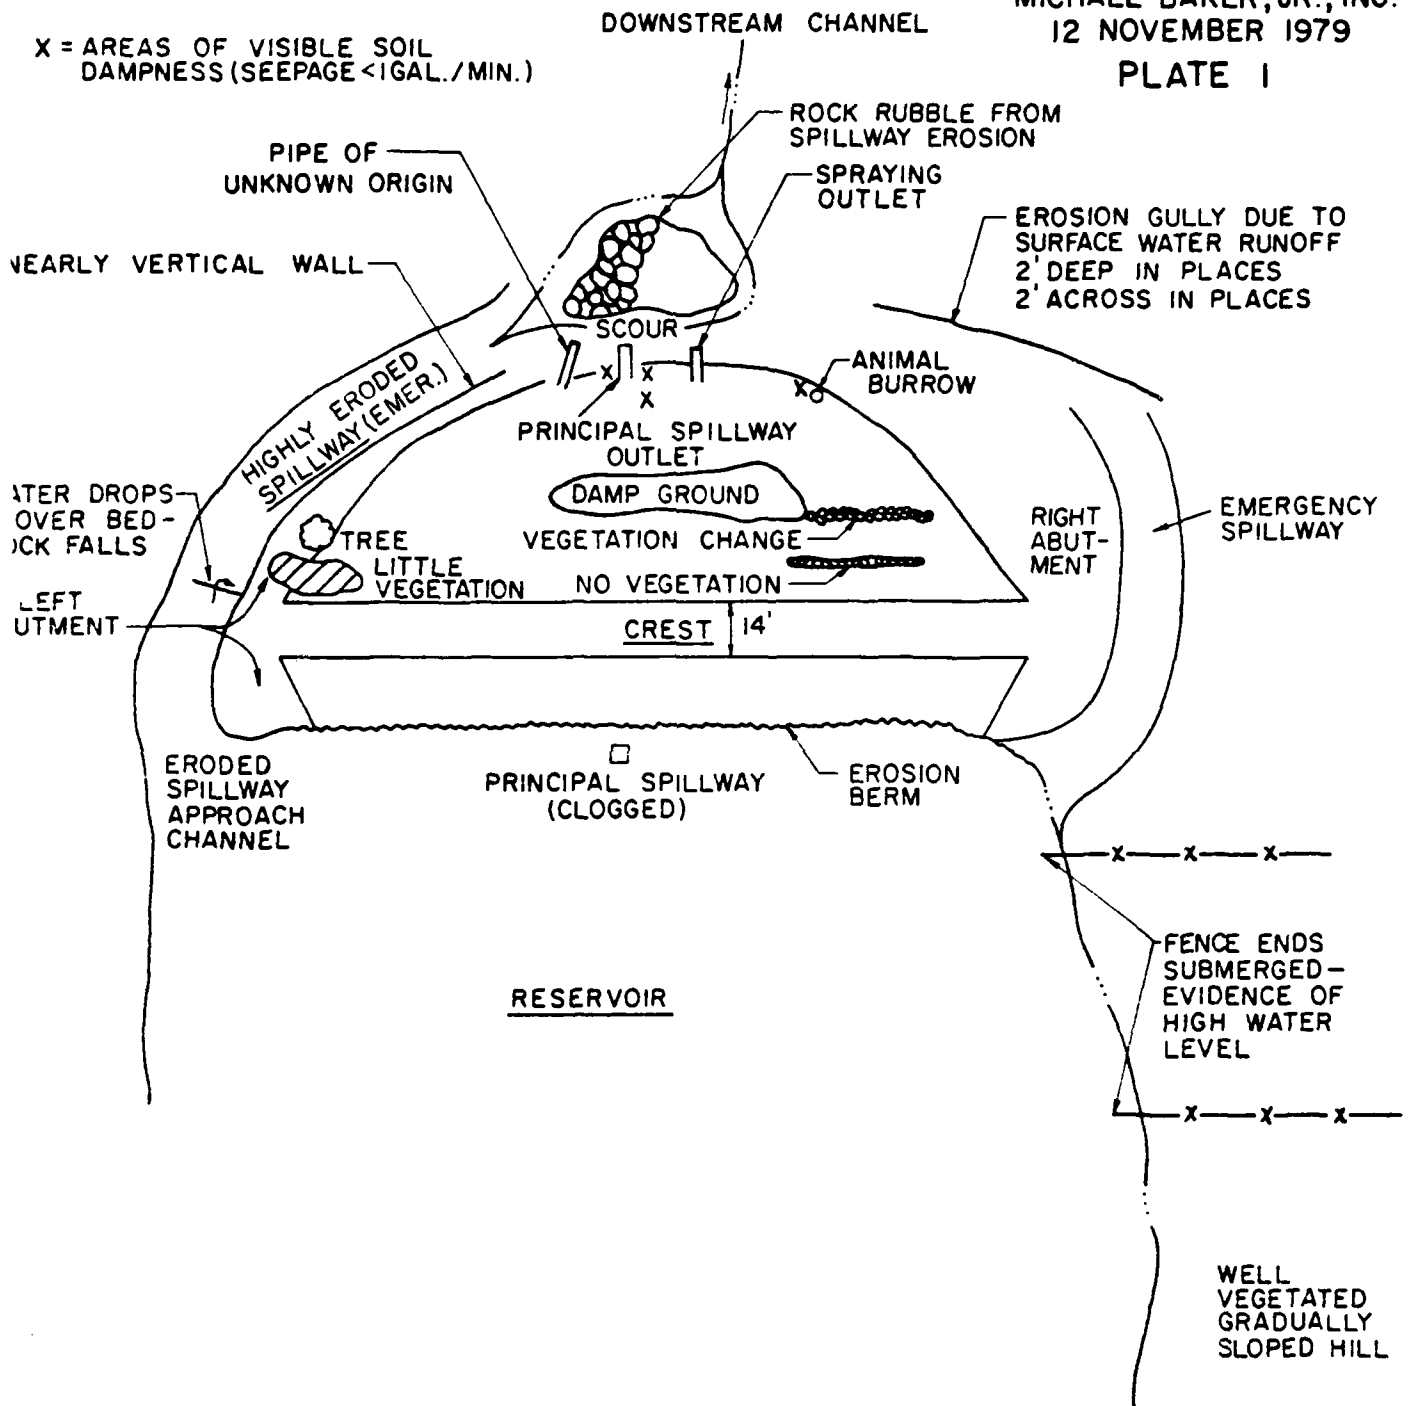
PLATE I

DOWNSTREAM EMBANKMENT SOMEWHAT IRREGULAR / SLIGHTLY GULLIED
BEDROCK OF SPILLWAY HIGHLY FRACTURED
STRIKE - 60° E DIP - 68°
WATER FLOWING THROUGH LEFT EMERGENCY SPILLWAY AT TIME OF INSPECTION
